CAYMAN ISLANDS SHIPPING REGISTRY

FLYER TO THE LARGE YACHT INDUSTRY

Fatal accident while launching Personal Water Craft.

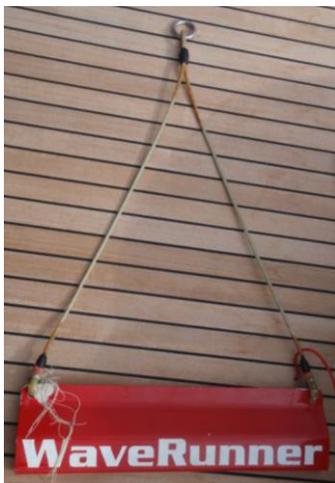
Sling and Spreader

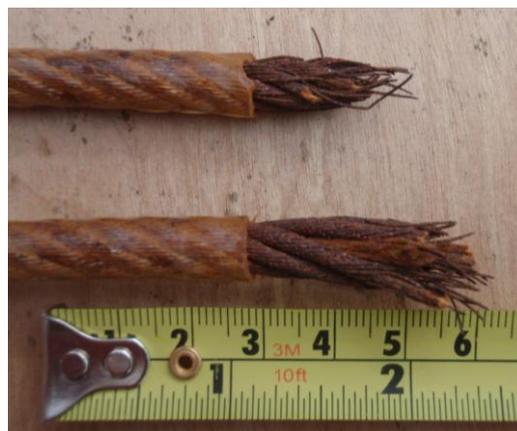
Upon inspection, the steel lifting slings in use were found to have failed in way of the crimped eye connection to the spreader beam. The slings were found to be heavily corroded and this corrosion had not been identified by the onboard maintenance and inspection regime. Further, the history and origin of the lifting sling was not readily apparent. It was stated that they were supplied with the PWC, but the model and manufacturer of the sling could not be identified and no manufacturer's documentation of certification could be located.

Failed slings

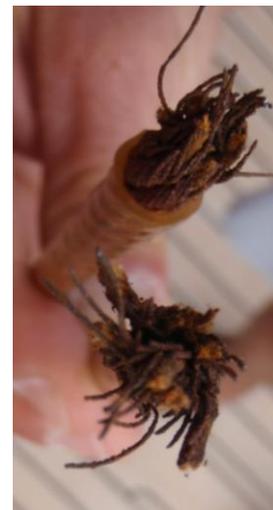
Corrosion of slings

- Loose gear should be visually inspected before each use and be integrated into the onboard maintenance, inspection and testing regime.
- Examinations of lifting appliances and loose gear should be carried out by persons competent, by virtue of their knowledge and experience, to do so.

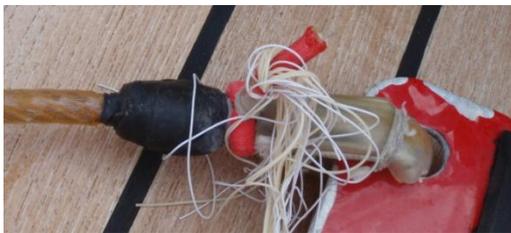
With “protective” tape

- When visually inspecting loose gear, sufficient areas under tape and other “protective coverings” should be inspected such that the overall condition of the loose gear can be assessed.

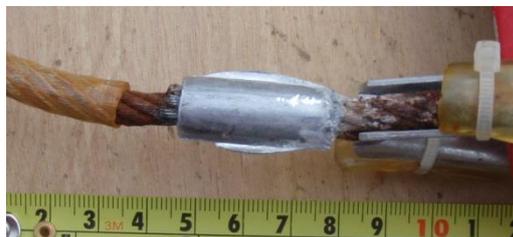
Tape removed
