CAYMAN ISLANDS SHIPPING REGISTRY

FLYER TO THE LARGE YACHT INDUSTRY

Fatal accident while launching Personal Water Craft.

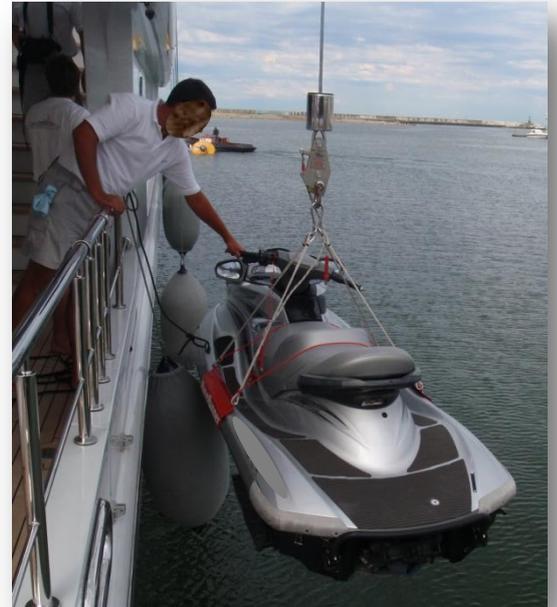
Upon inspection, the steel lifting slings in use were found to have failed in way of the crimped eye connection to the spreader beam. The slings were found to be heavily corroded and this corrosion had not been identified by the onboard maintenance and inspection regime. Further, the history and origin of the lifting sling was not readily apparent. It was stated that they were supplied with the PWC, but the model and manufacturer of the sling could not be identified and no manufacturer's documentation of certification could be located.

- The risks inherent in all lifting operations, including the launching of watercraft, must be rigorously assessed and safe working practices developed.

- Procedures for lifting operations should be developed, adhered to during use and periodically reviewed.
- “Man Riding” activities should only be carried out using certified and tested loose gear. The guidance in the *Code of Safe Working Practices for Merchant Seamen*, section 15.2 (Working aloft and outboard) and section 21.2 (Use of lifting equipment) should be fully taken into account.

- Loose gear should be visually inspected before each use and be integrated into the onboard maintenance, inspection and testing regime.
- Examinations of lifting appliances and loose gear should be carried out by persons competent, by virtue of their knowledge and experience, to do so.

- When visually inspecting loose gear, sufficient areas under tape and other “protective coverings” should be inspected such that the overall condition of the loose gear can be assessed.
